Rockland 1996 Landslide Assessment

City of Rockland

December 16, 2024

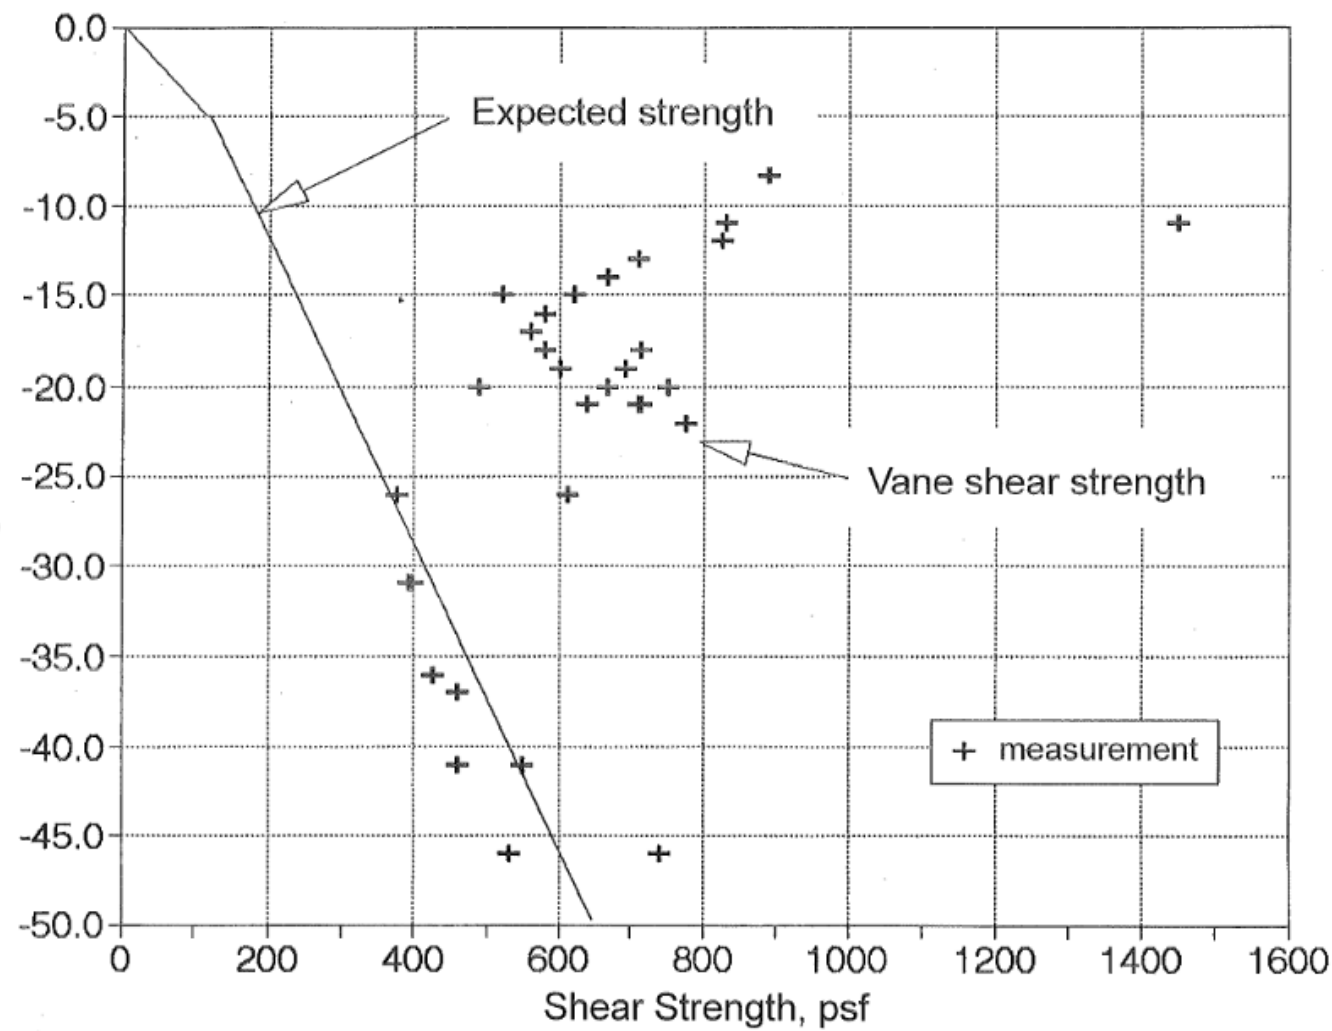
Figure 11. Diagram showing vane shear strength of the clay at various depths. Vane shear strength measurements of clay from borholes at the 1996 Rockland landslide site are shown by "+" symbols. The line drawn on the diagram shows the expected strength of normally consolidated clay of the Presumpscot Formation.

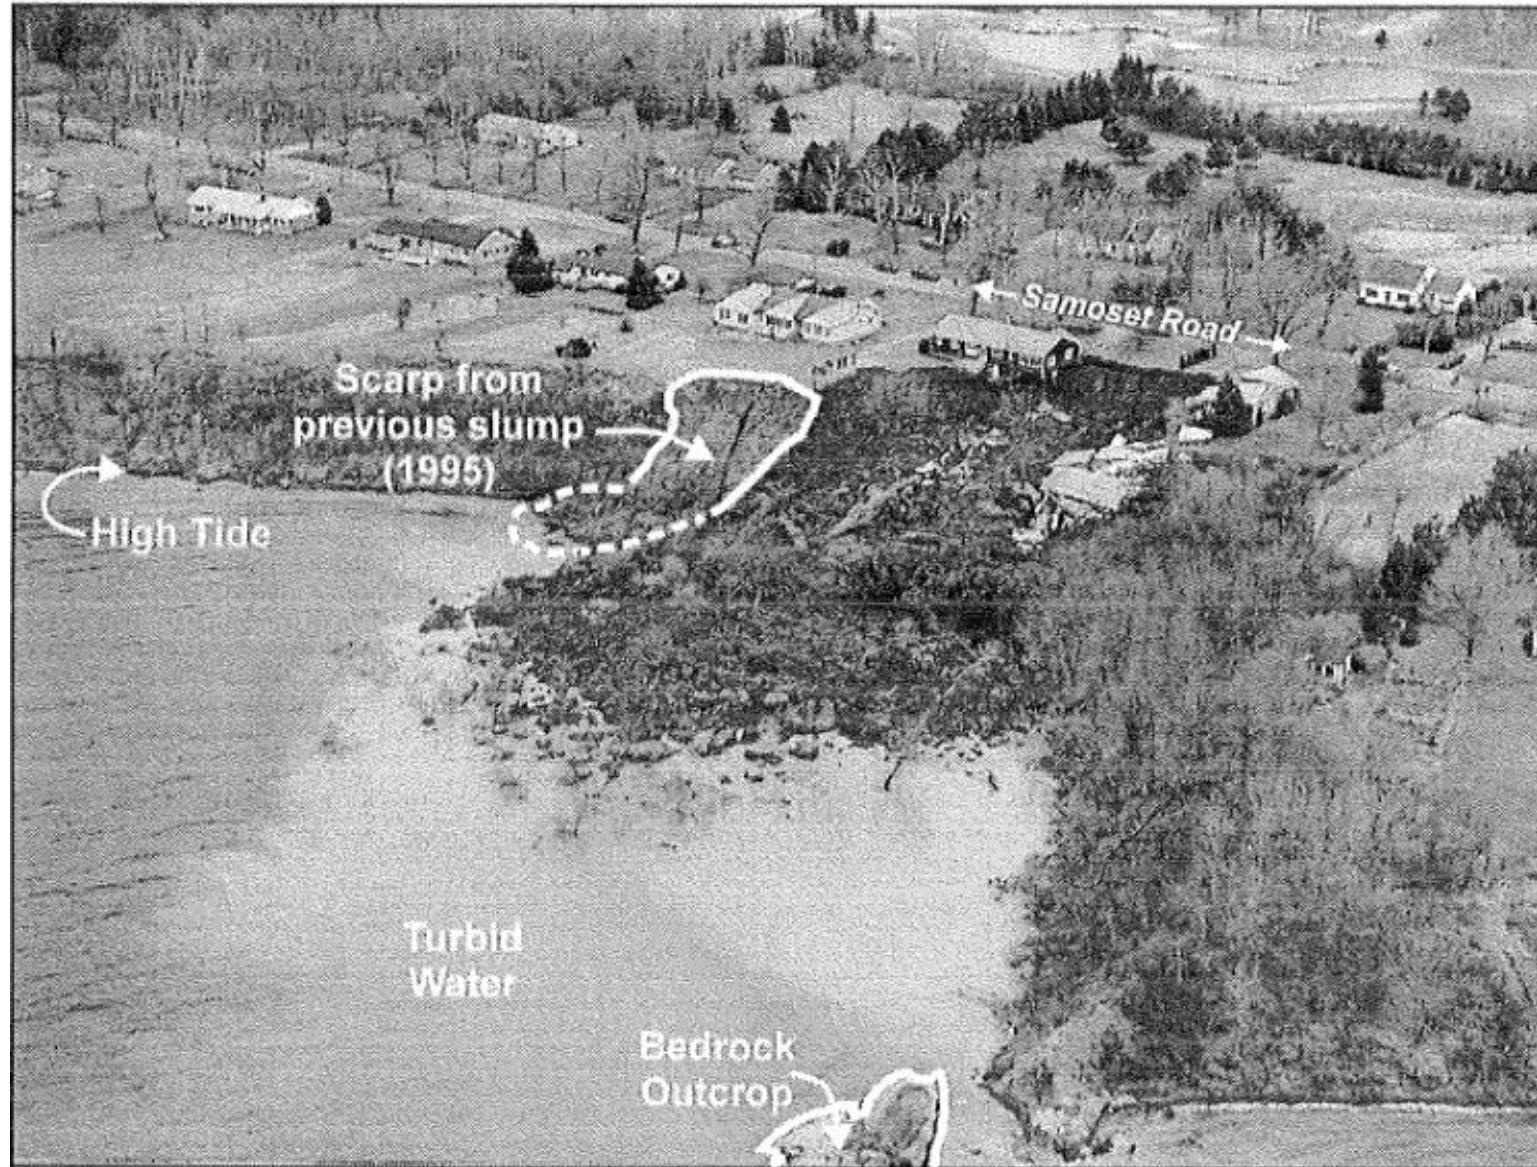
1995 Slump

- Smaller slide (slump) did occur adjacent to 1996 slide in 1995
- May have reduced lateral support of the bluff that eventually failed in 1996

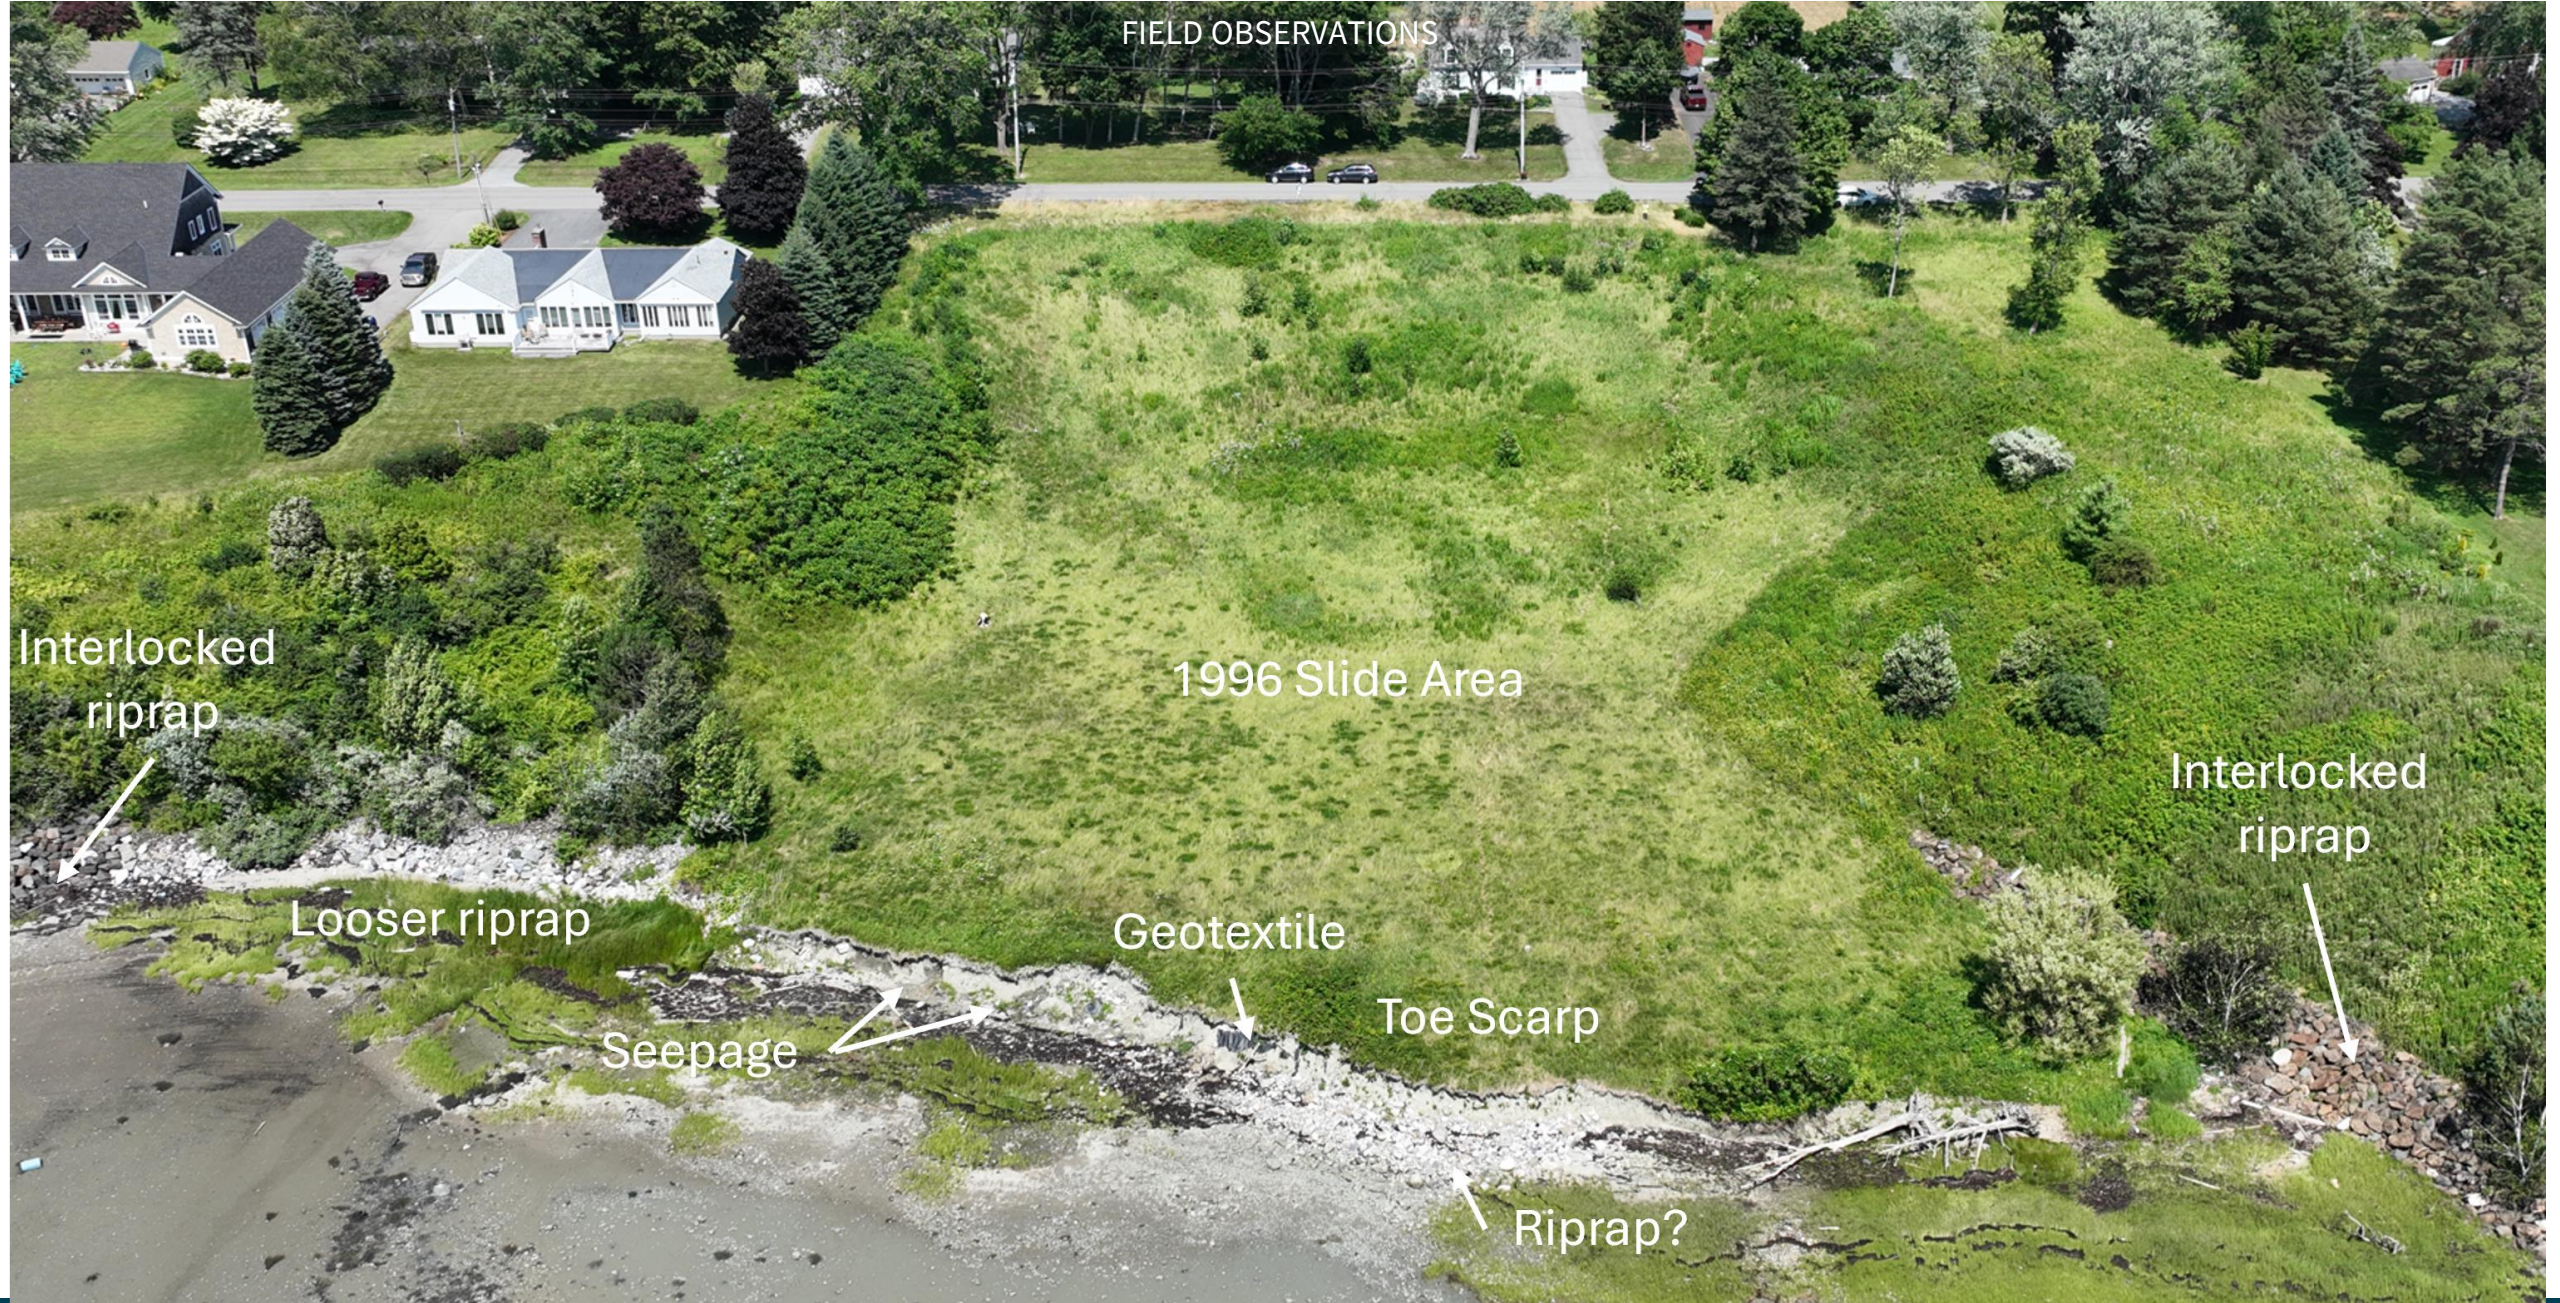
FIELD OBSERVATIONS

Interlocked riprap

1996 Slide Area

Looser riprap

Geotextile

Toe Scarp

Seepage

Riprap?

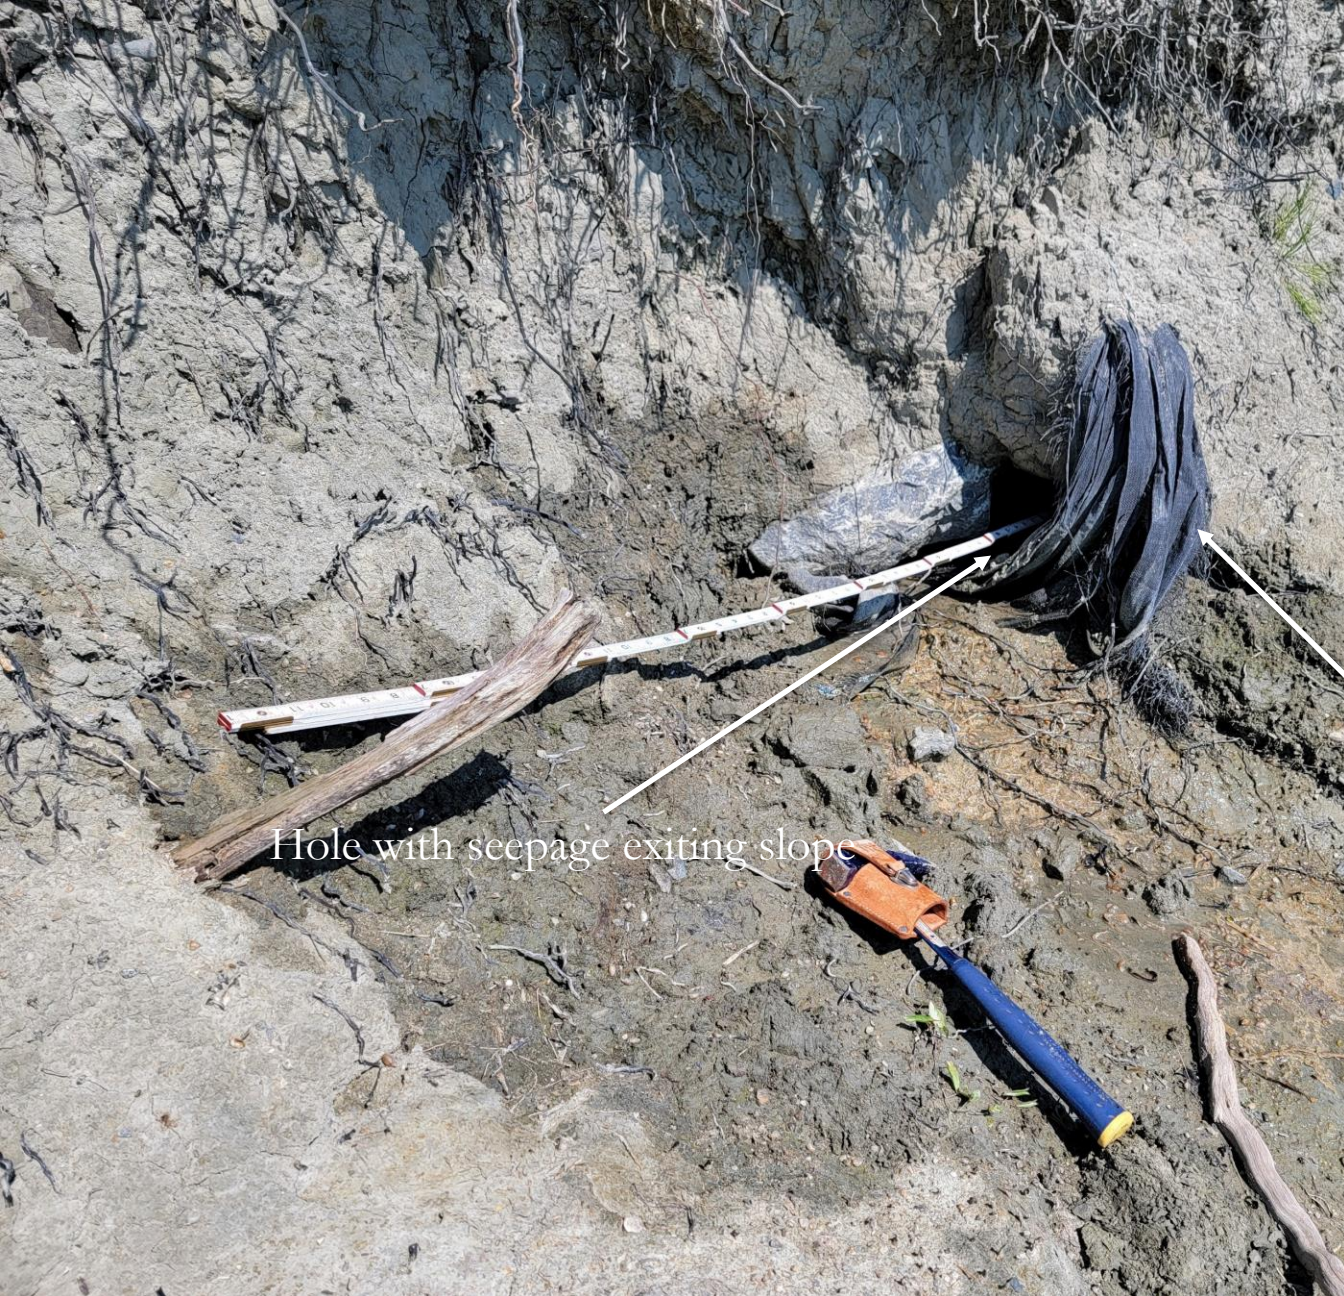
Hole with seepage exiting slope

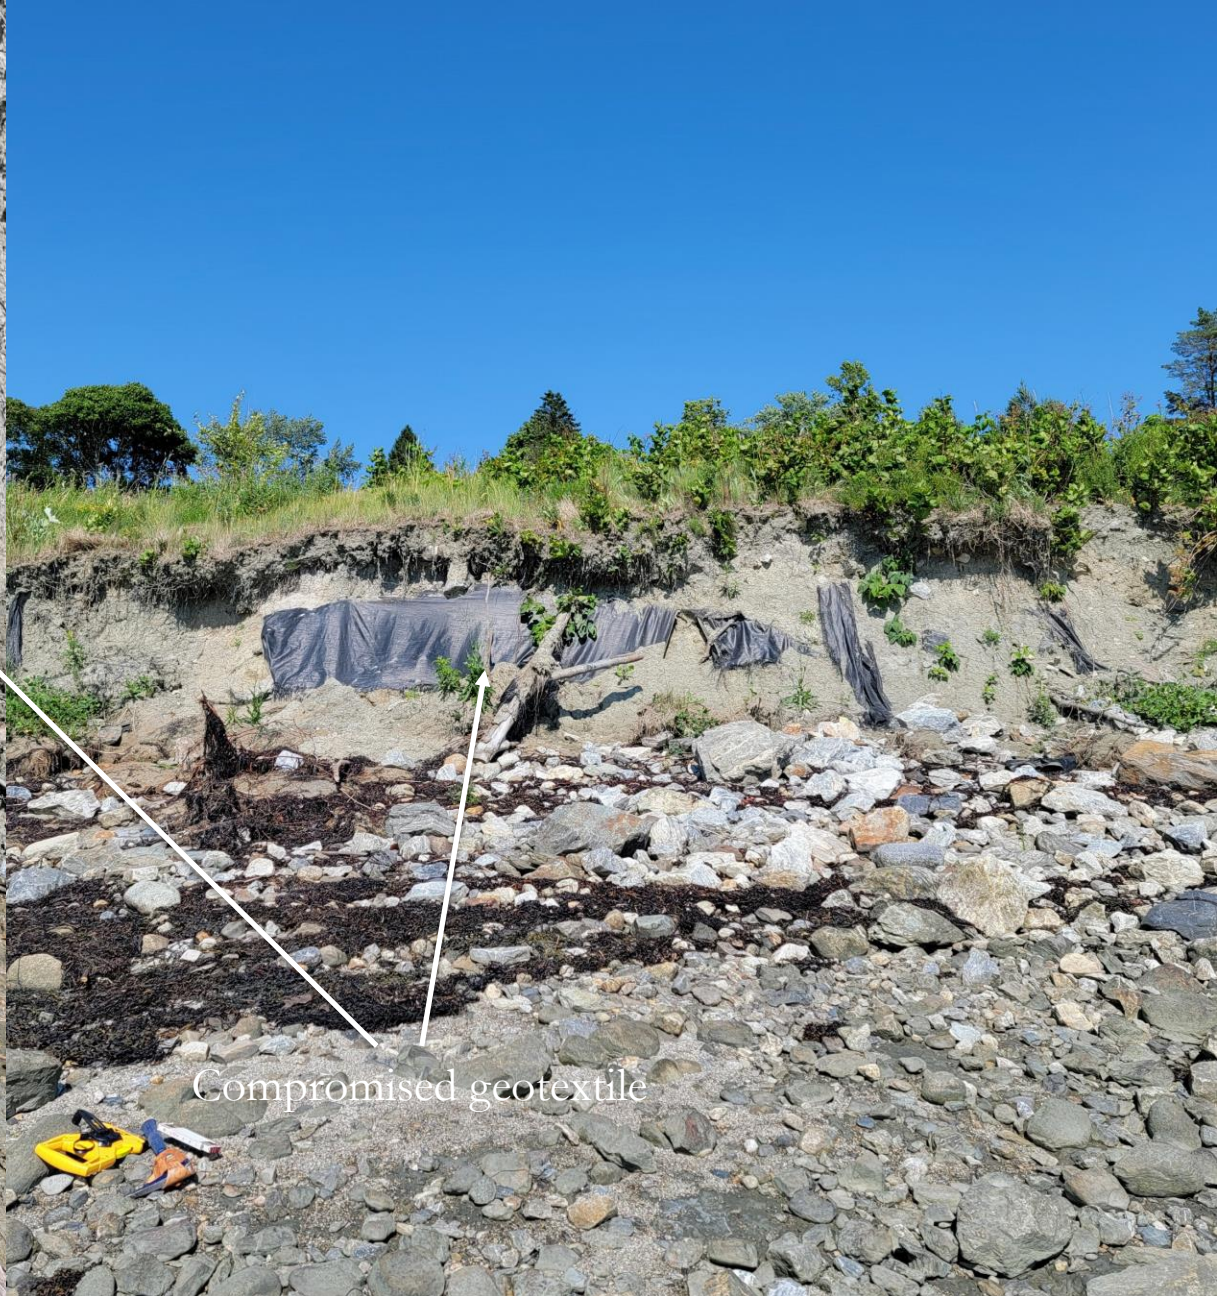
Compromised geotextile
