Rockland 1996 Landslide Assessment

City of Rockland

December 16, 2024

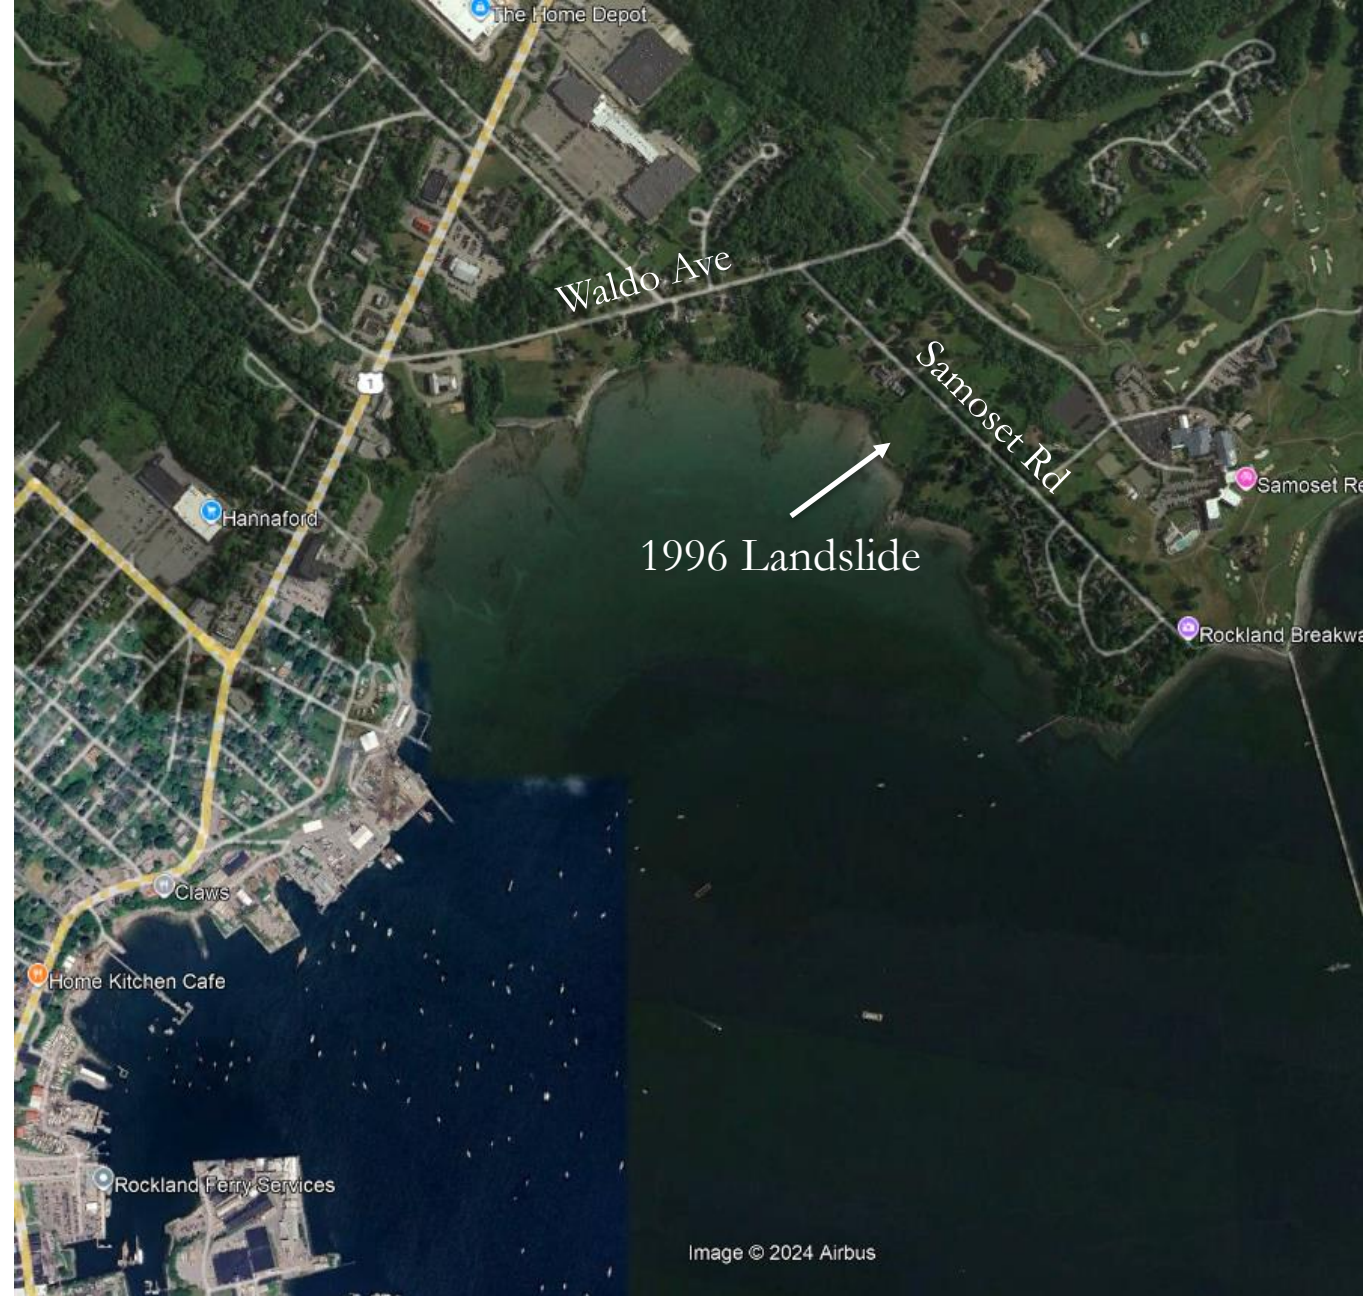
- Occurred April 16, 1996
- Bluff ~50 ft tall, 2H:1V
- Scarp ~200 ft landward of bluff crest
- Deposited soil/debris ~250 ft seaward of bluff toe
- 3.5 acres disturbed
- Two homes destroyed
- No casualties

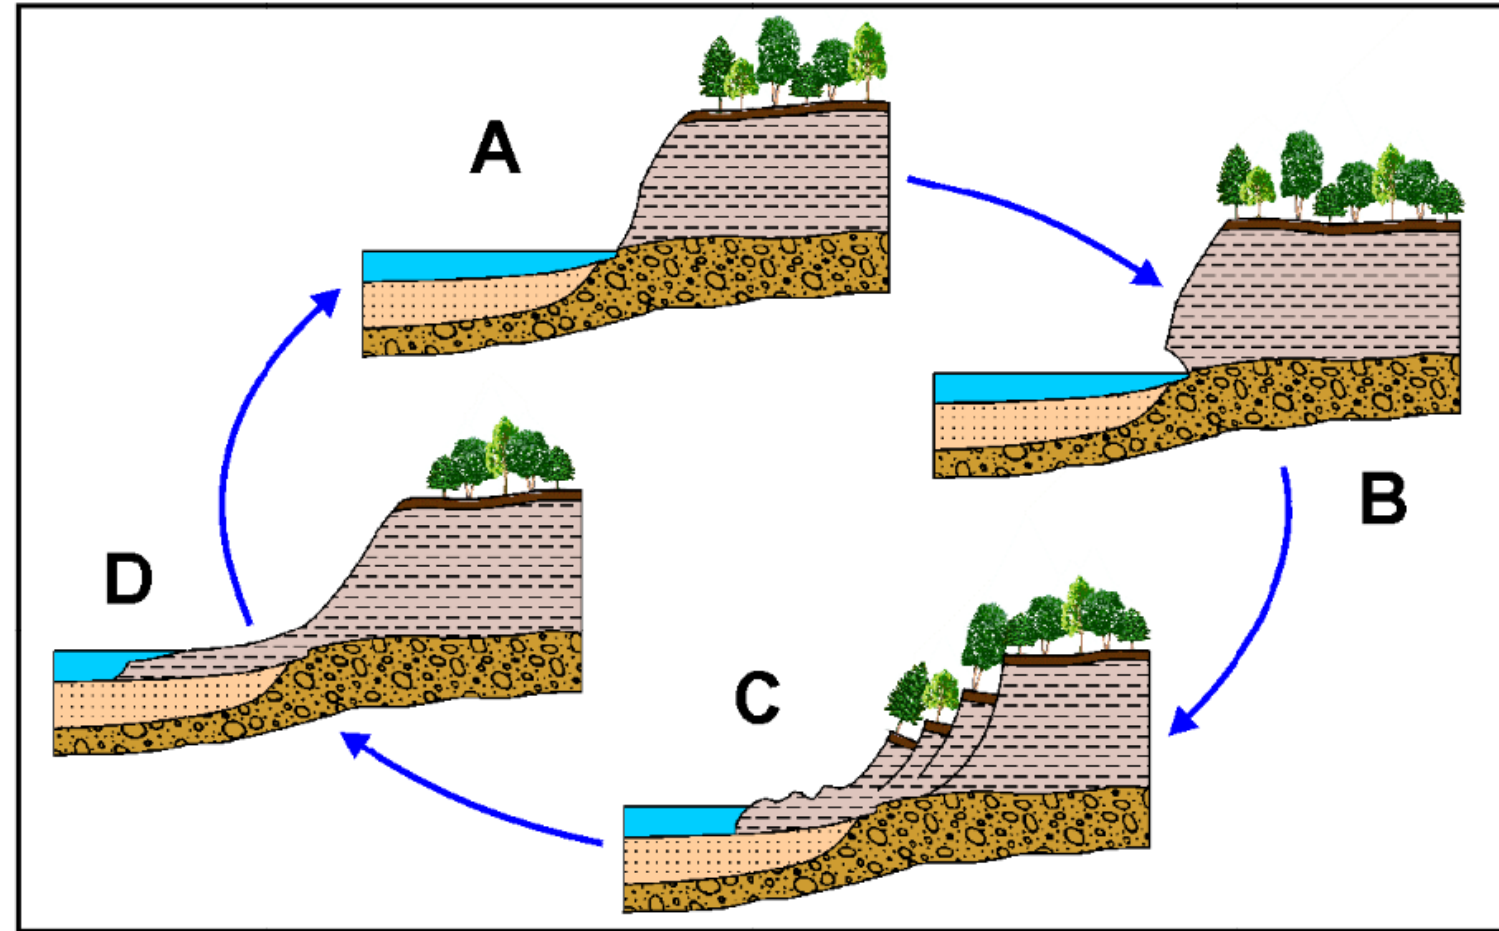
- Thickness of weaker Presumpscot Formation
- Bluff height and steepness
- High groundwater
- Potential artesian conditions
- Large precipitation event and snow melt

Figure 2. Life cycle of a landslide on a bluff composed of sediment (modified from Kelley and others, 1989).

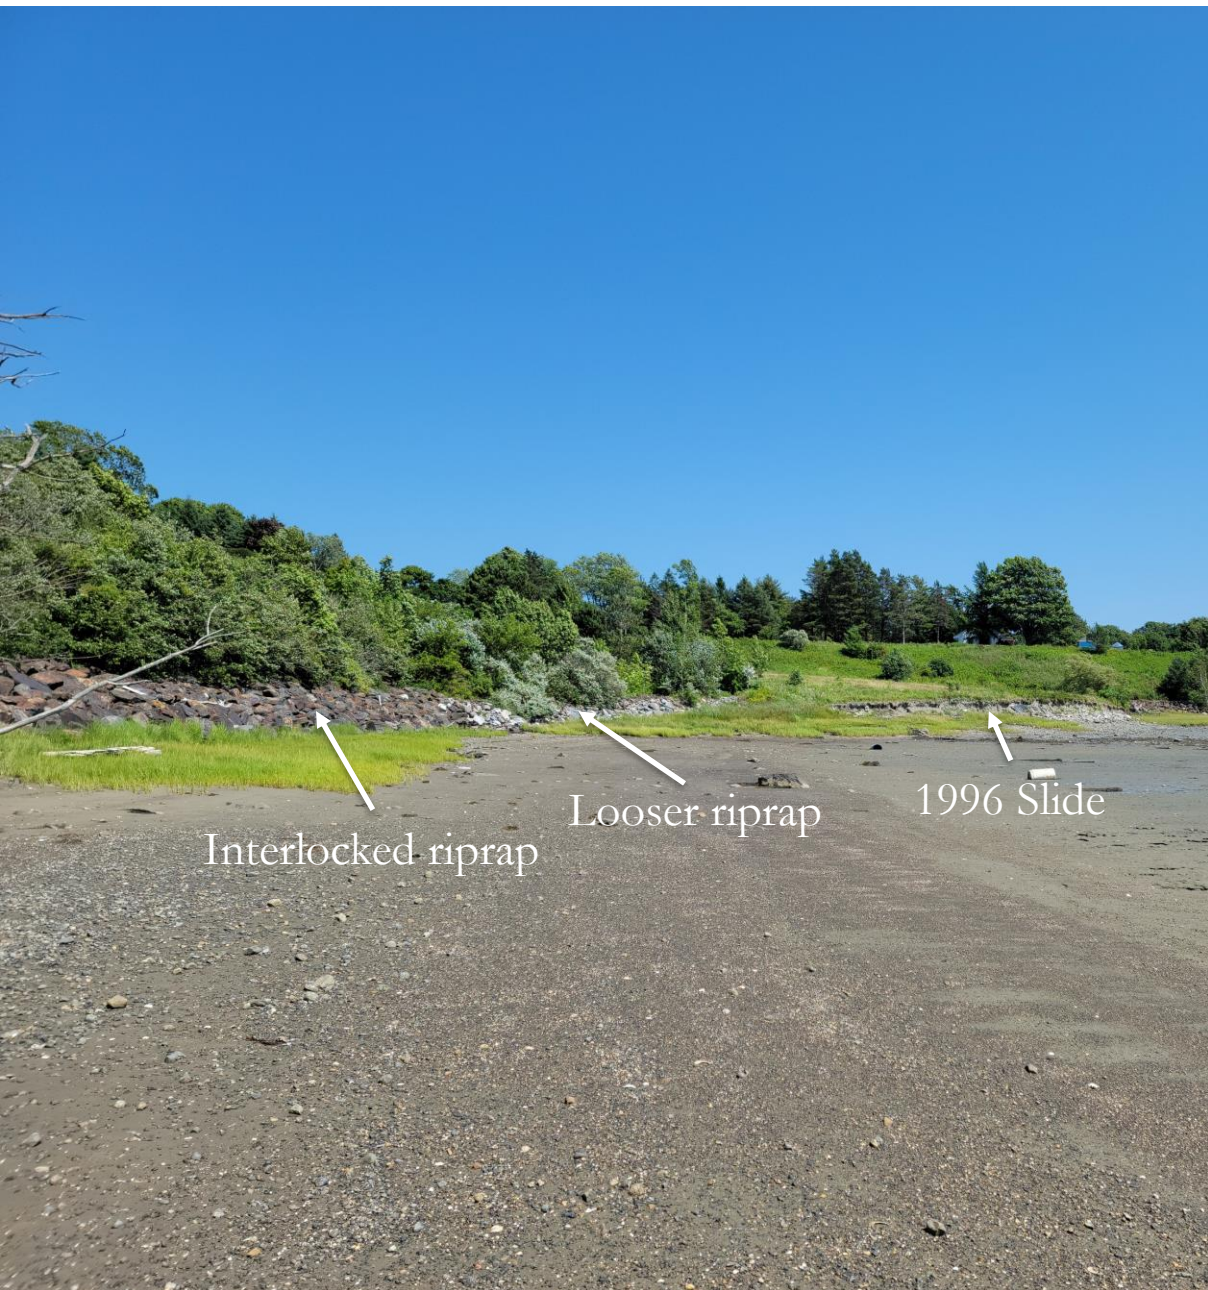
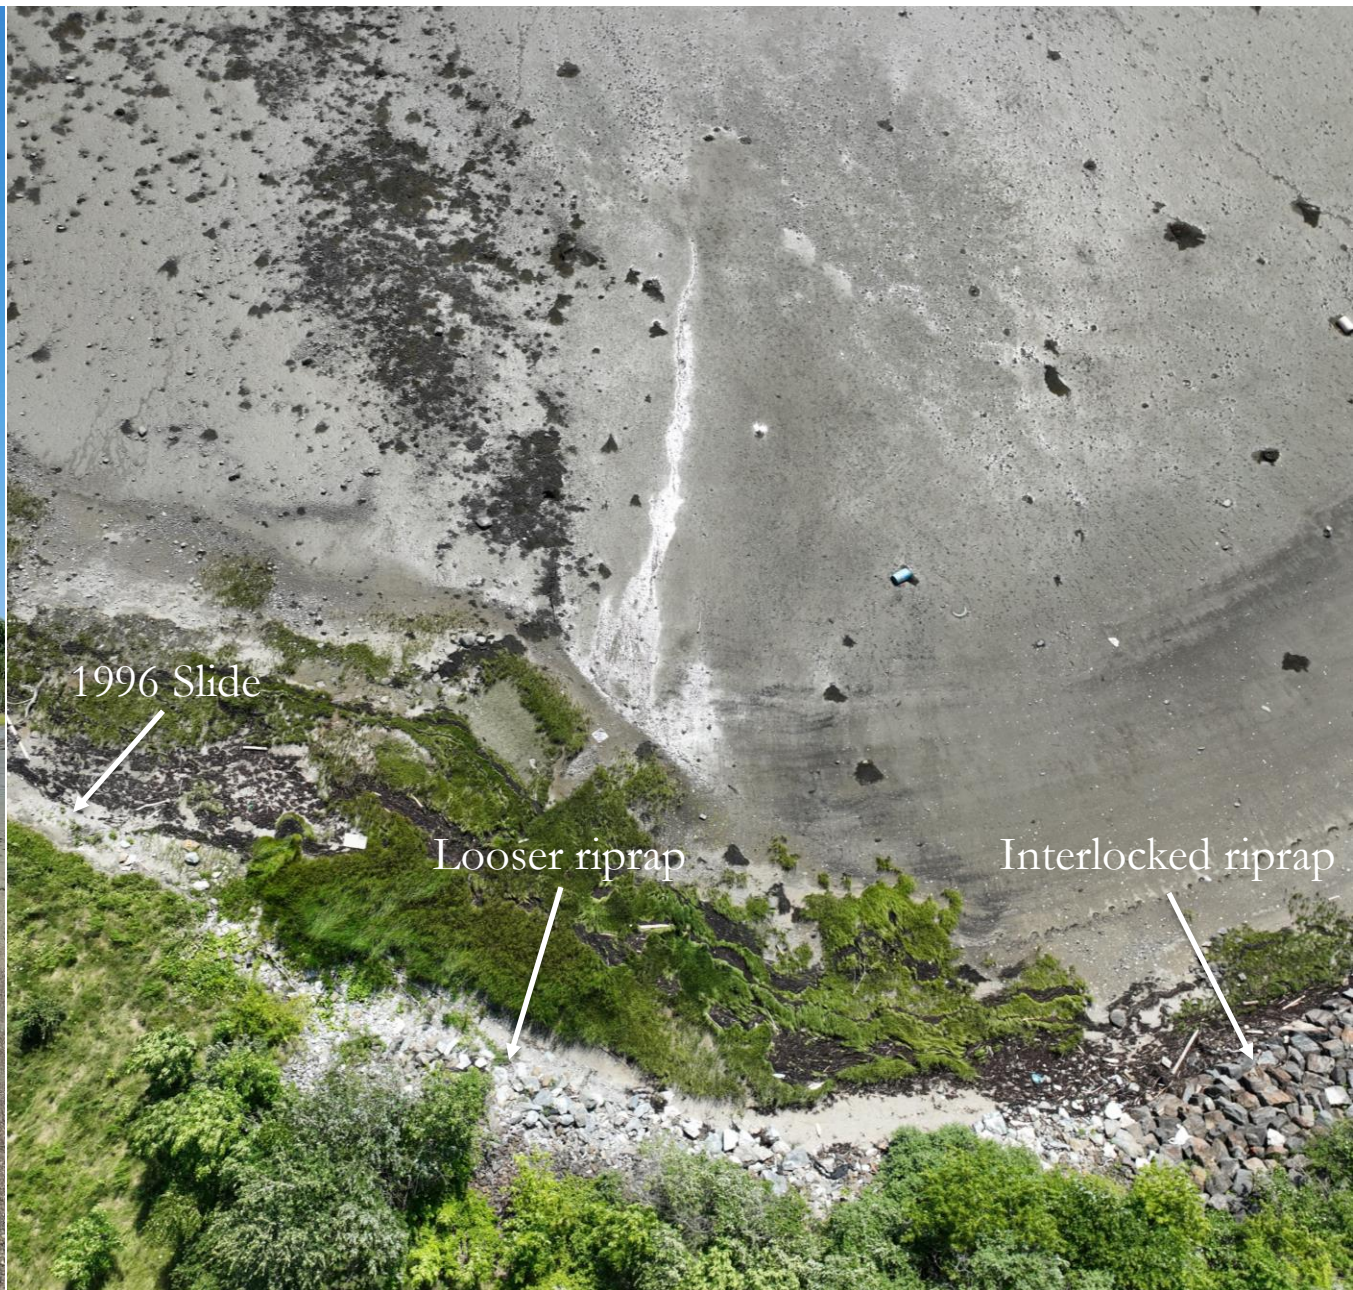
Interlocked riprap

1996 Slide Area

Looser riprap

Geotextile

Toe Scarp

Seepage

Riprap?

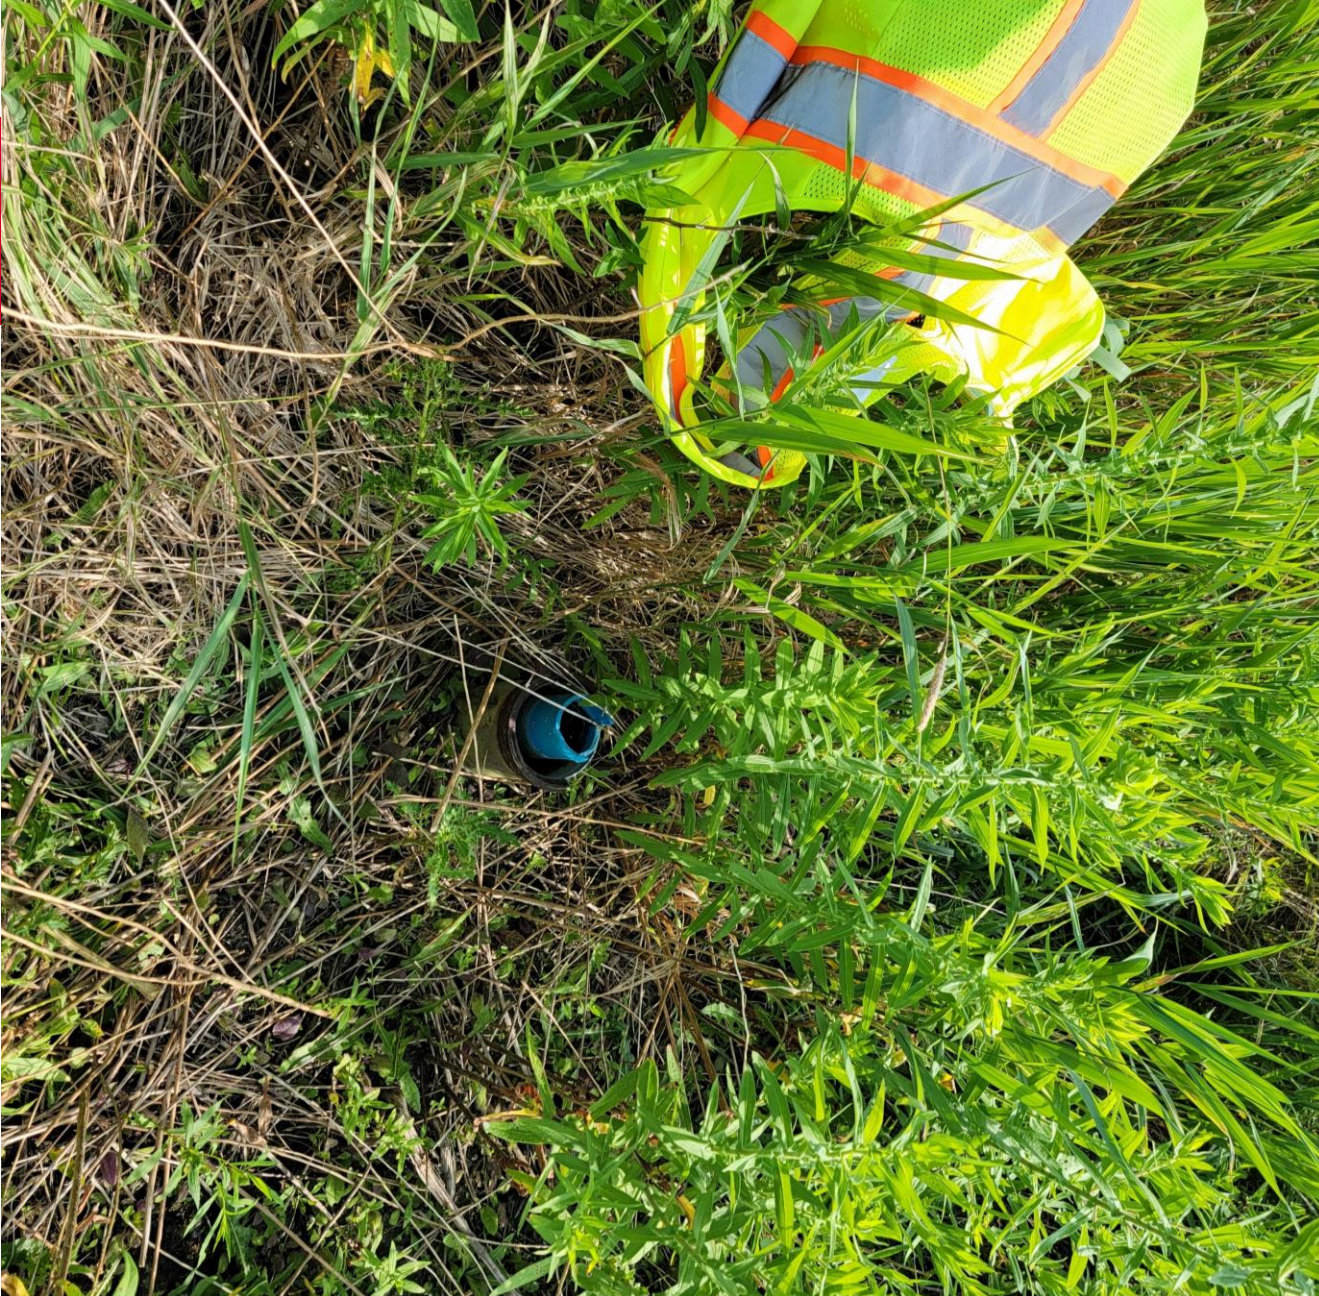
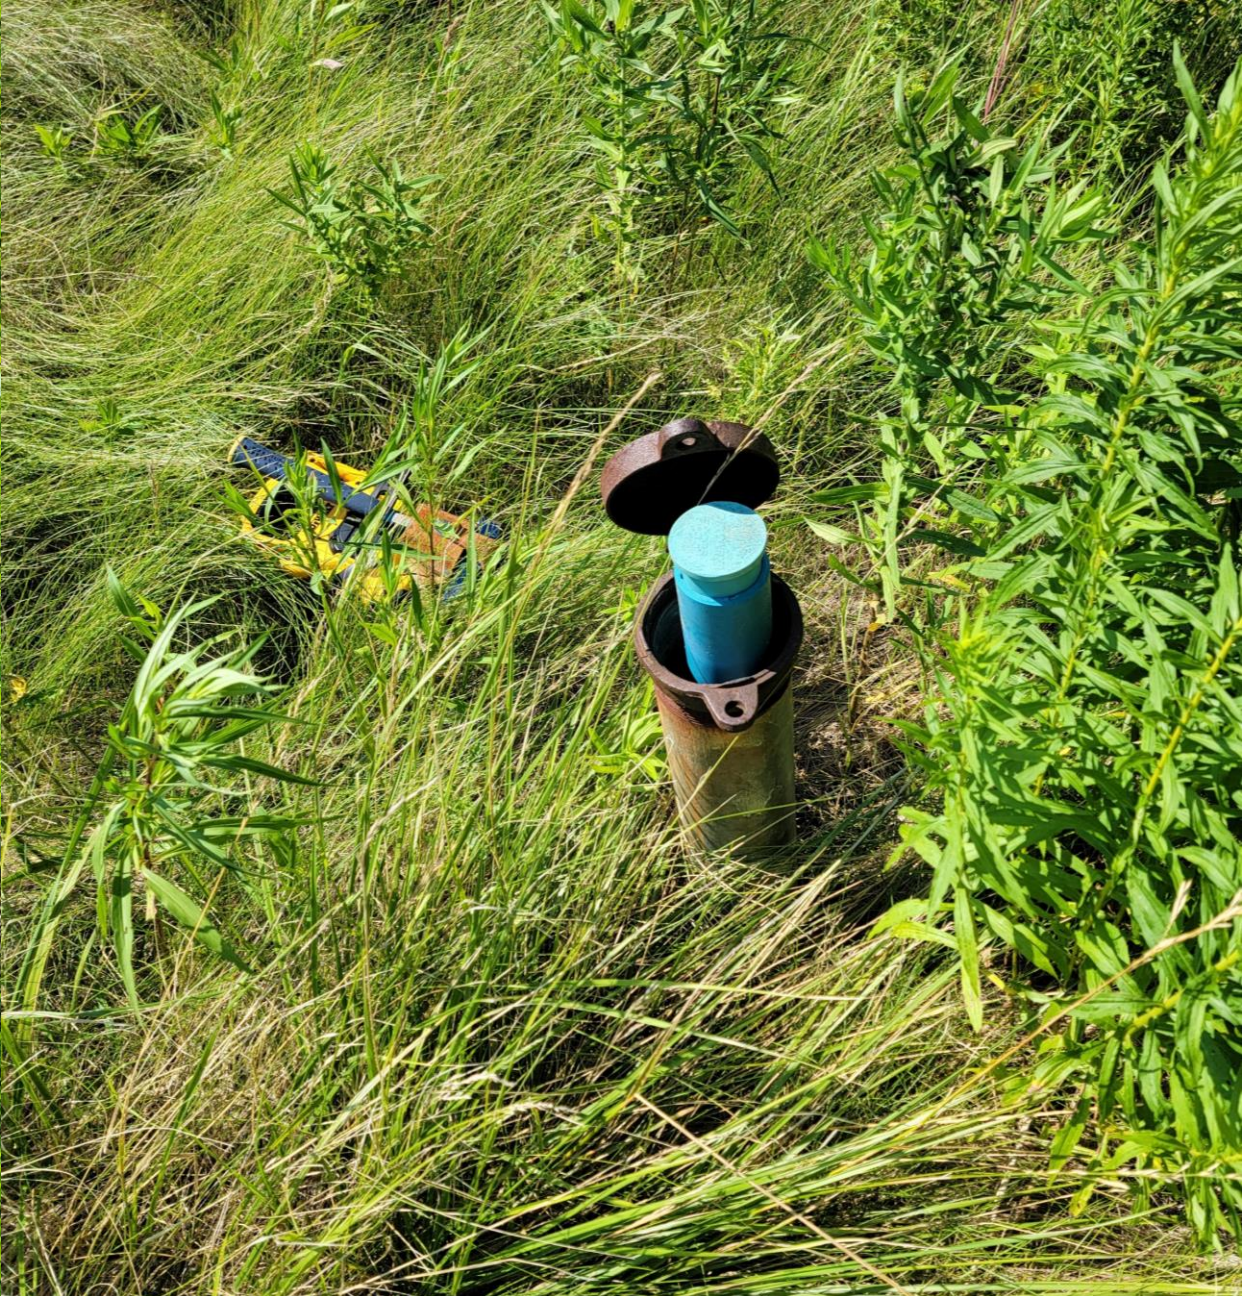
Compromised geotextile

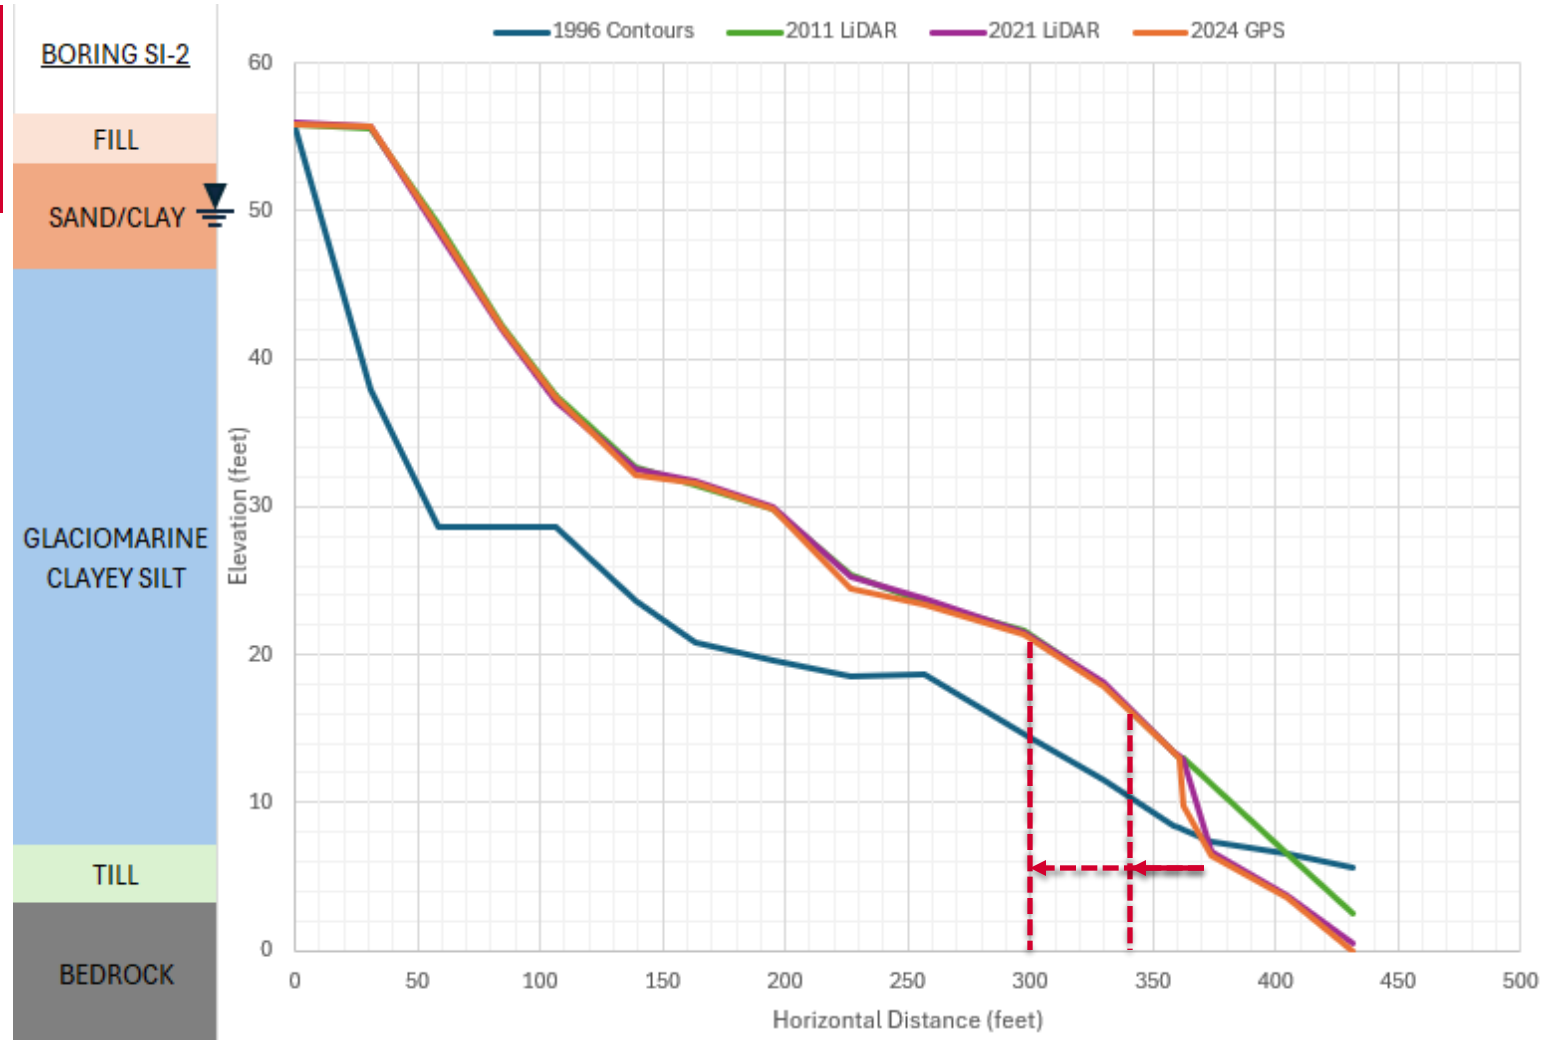
- Rate of erosion has slowed due to reach of tidal zone and neighboring armoring
- Estimate ~950 square yards of additional erosion in 10 years with current configuration
- Original embayment ~2,850 square yards of loss

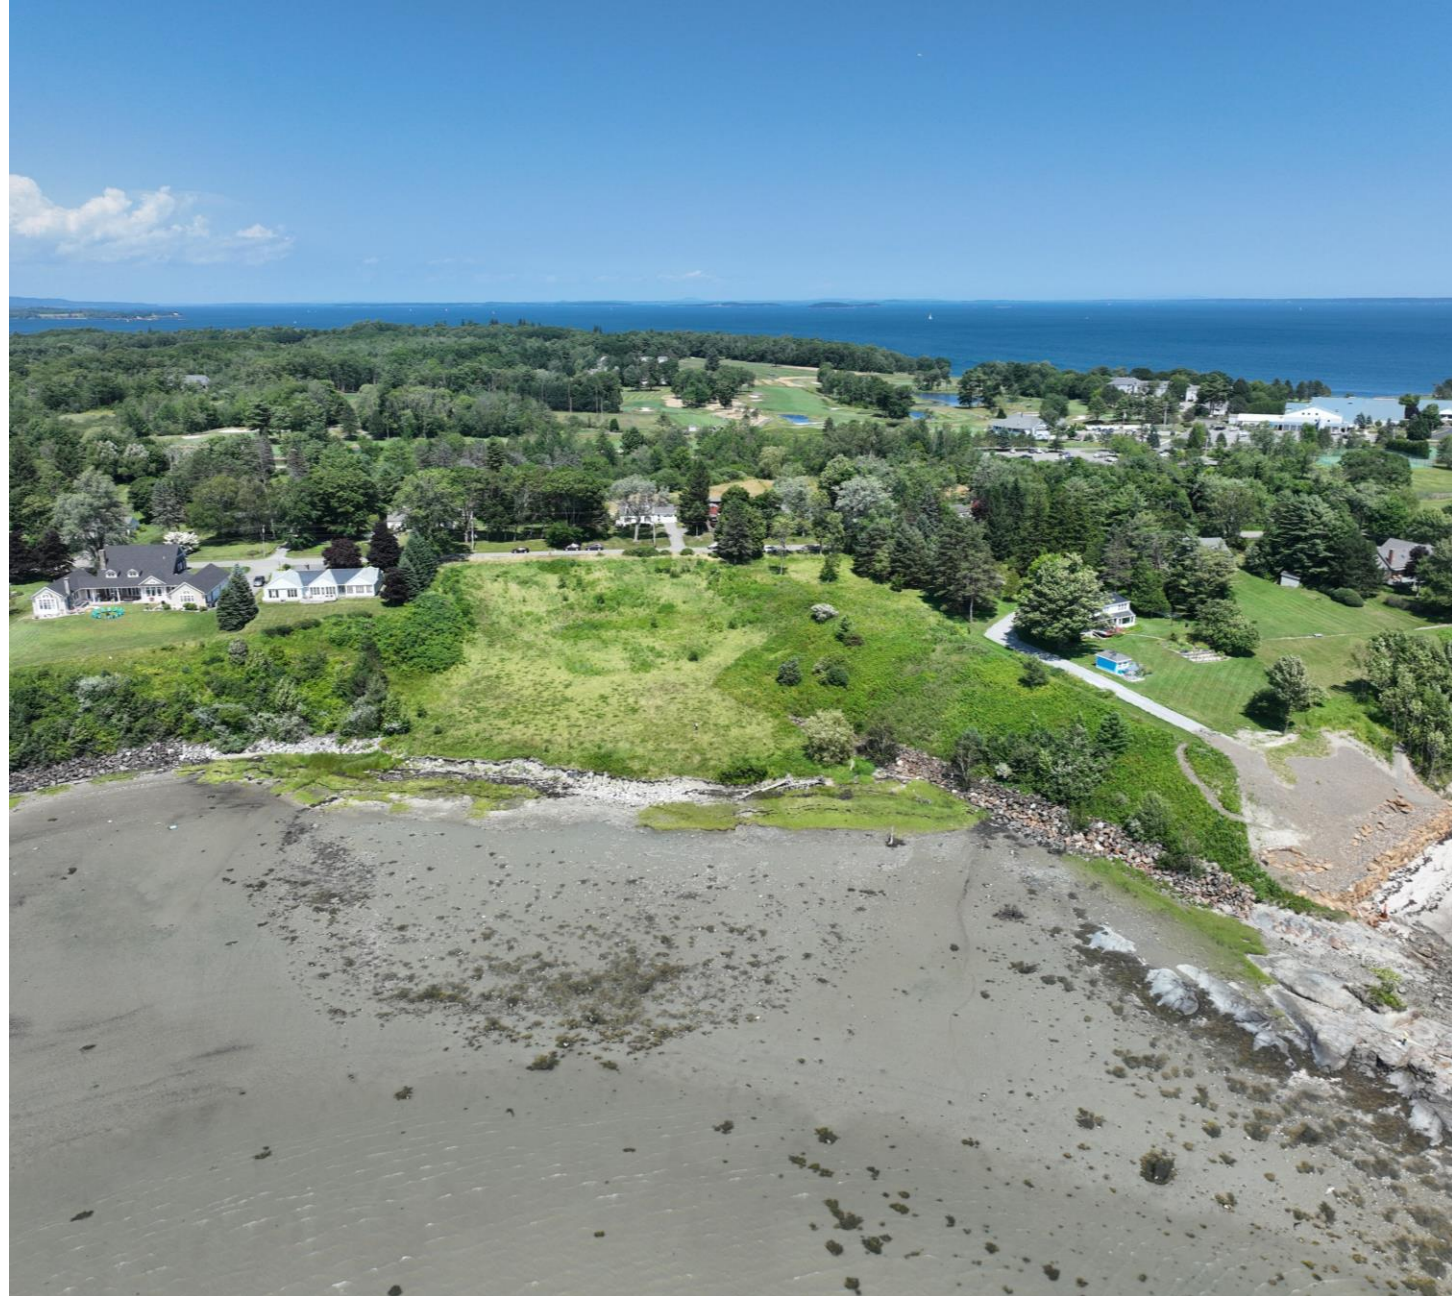
- Landslide not reactivated
- Toe has experienced erosion
- Seepage exiting slope
- Riprap armoring appears effective at limiting erosion if properly sized
- Erosion to continue if not armored, but has slowed
- Possible side slopes of neighboring properties could slump with enough recession of toe of 1996 slide

- Check state lidar and satellite imagery annually, utilize data to monitor changes to slide area.
- Clear low brush and mow slope annually to allow for better observation and collect drone imagery for better visual observation and change detection.
- Attempt to find observation wells noted in 1996 report. If found, take readings monthly for two years and then quarterly if readings stable.
- Attempt to find third inclinometer casing and start taking readings, monthly for first year and then quarterly or less if readings consistent.
- If movement detected, assess slope immediate mitigation or long-term solutions
- Attempt to locate records of construction / cleanup efforts
- Consider armoring toe of slide area
- Development not recommended without further study
